Section 22 Connecticut

Connecticut Coastal Structures Inventory Study

PHASE I - NEW LONDON COUNTY

APPENDIX B
MYSTIC QUADRANGLE
RECORDS OF STRUCTURES WITH PHOTOGRAPHS

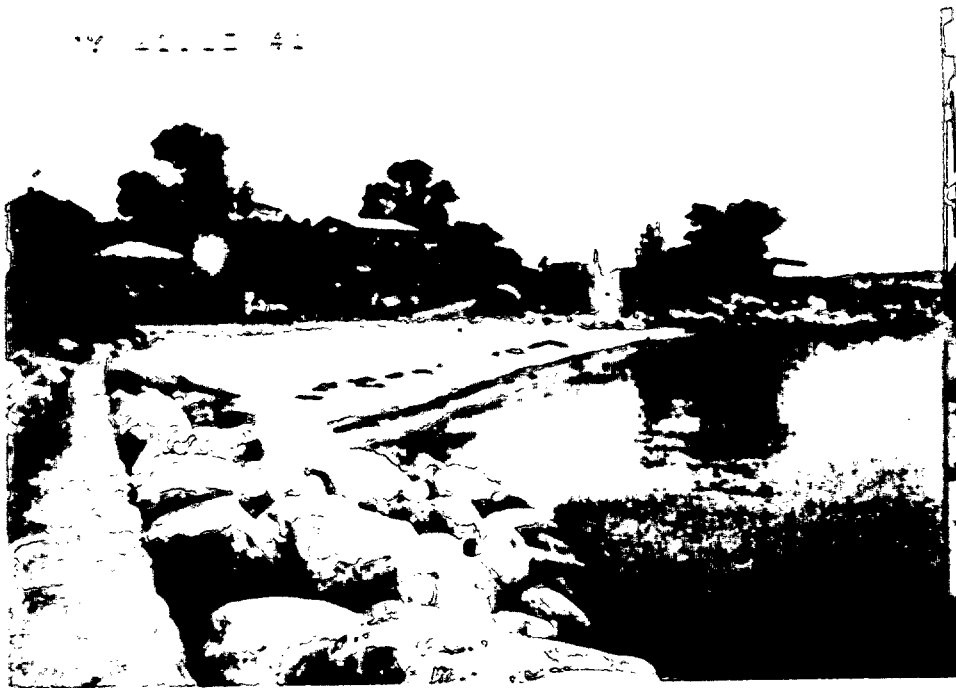
TYPE OF STRUCTURE: 2 GROINS CONDITION: GOOD
MAIN FUNCTION : MAINTAINS SANDY BEACH AREA
MATERIAL : STONE

#1 ROLL 5 NEG 14 FROM EAST LOOKING WEST TOWARDS POINT
#2
#3
#4
#5

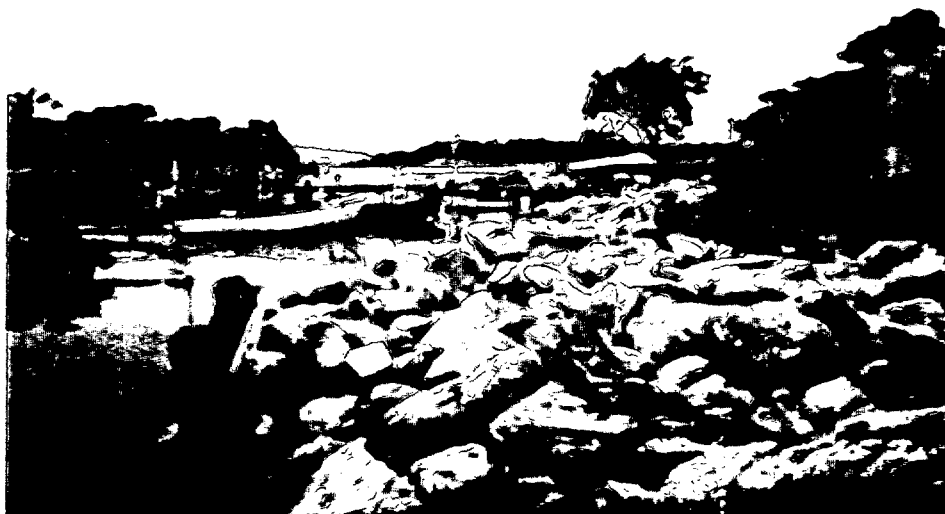
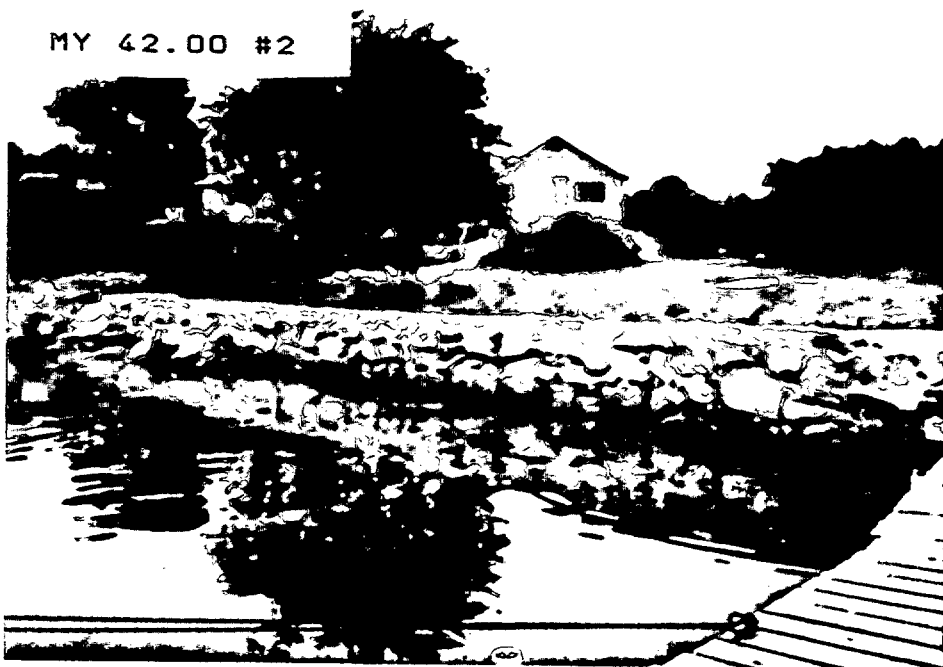
MY 42.00 #1

CONDITION: FAIR

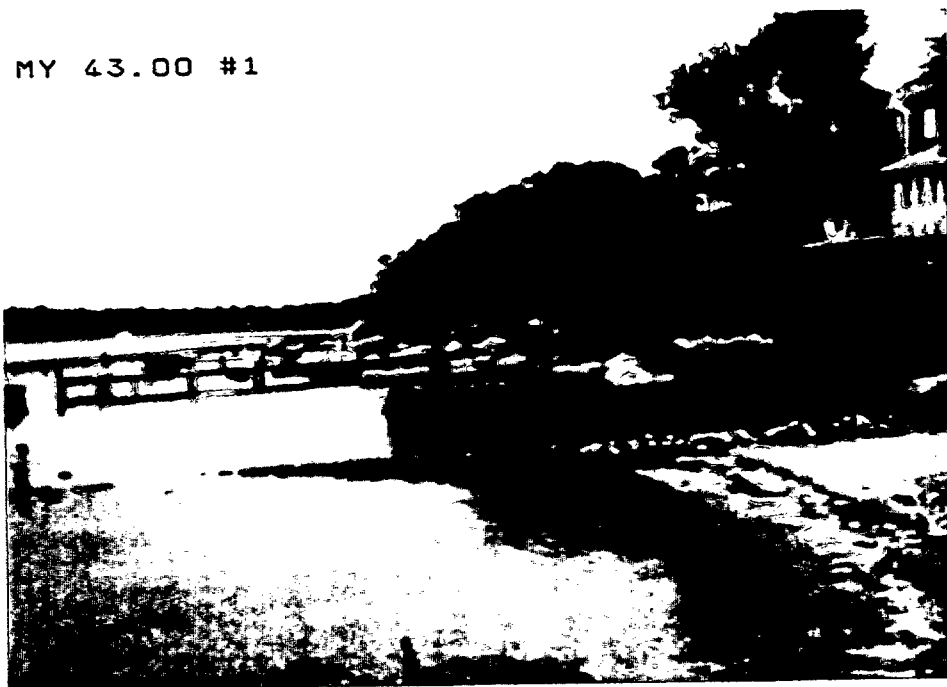
MY 43.00 #1

TYPE OF STRUCTURE: RIPRAP CONDITION:
MAIN FUNCTION : PREVENTS EROSION OF WESTSHORE OF LATIMER POINT
MATERIAL : ROCK

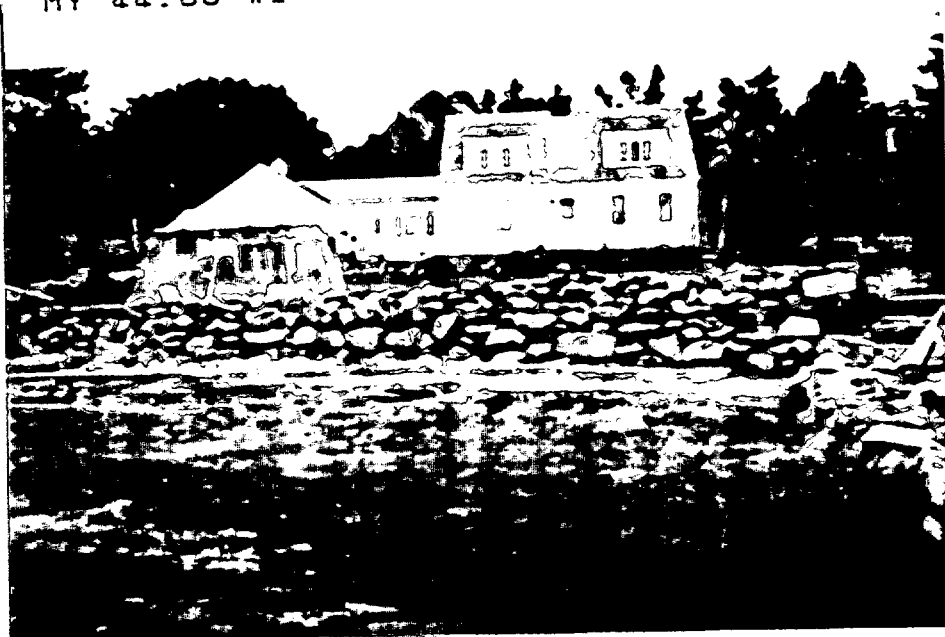
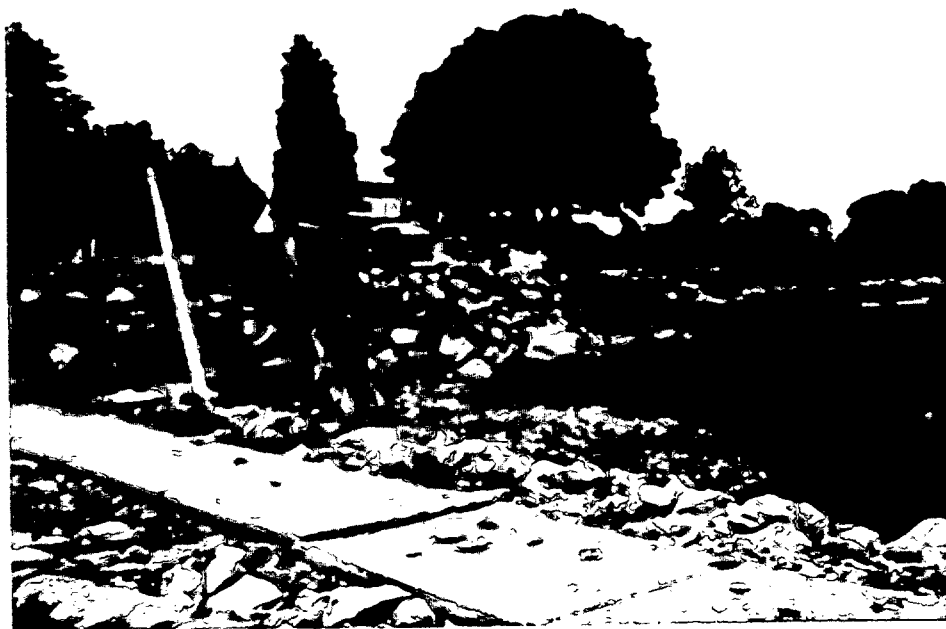
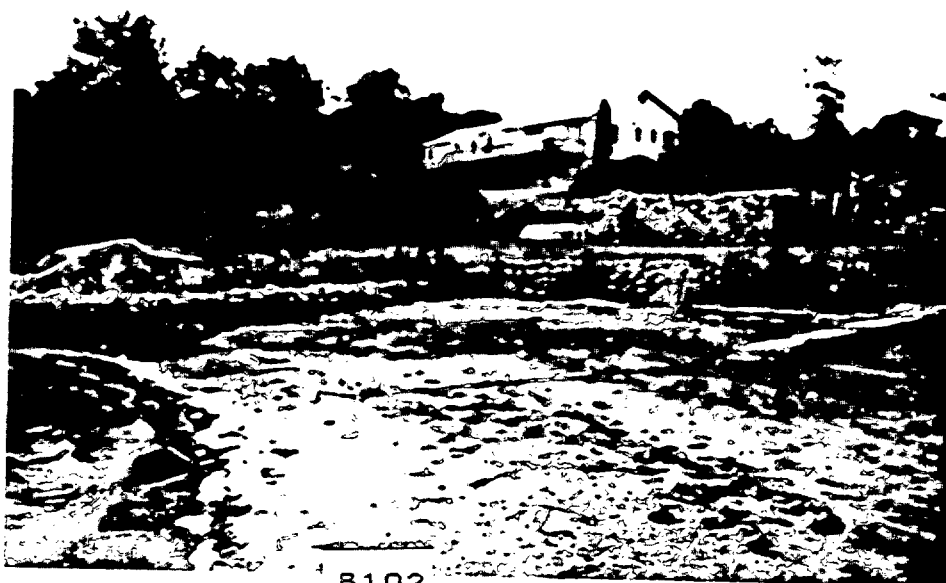
MY 44.00 #1

TYPE OF STRUCTURE: SEAWALL CONDITION: FAIR
MAIN FUNCTION : PROTECTS PRIVATE LOT FROM EROSION
MATERIAL : ROCK

AREA - MARSH WITH INTERMITTENT PATCHES OF SAND - NATURALLY
DEPOSITED LOOSE BOULDERS

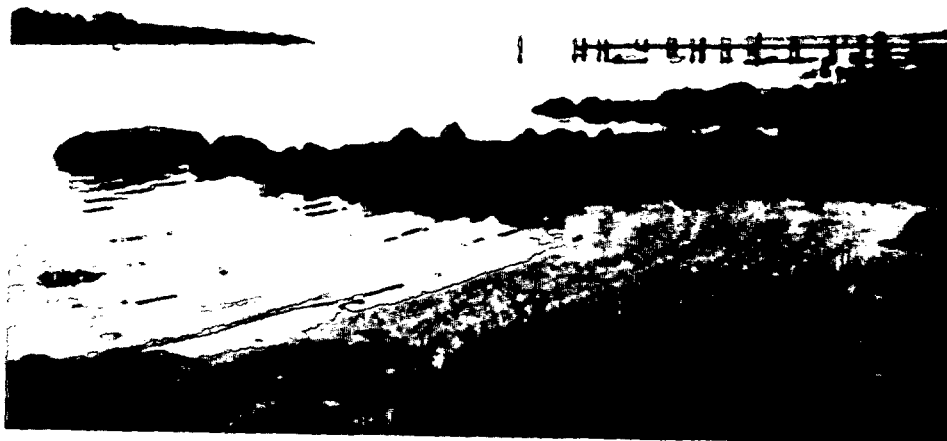
MY 46.CC #1

TYPE OF STRUCTURE: GROINS (SERIES) CONDITION: POOR
MAIN FUNCTION : RETAINS/PROTECTS SMALL PRIVATE BEACHES
MATERIAL : ROCK

AREA - SALT MARSH WITH SANDY SHORE & LOOSE BOULDERS. SAND IN
LITTLE BAY DRIFTS CLOCKWISE.

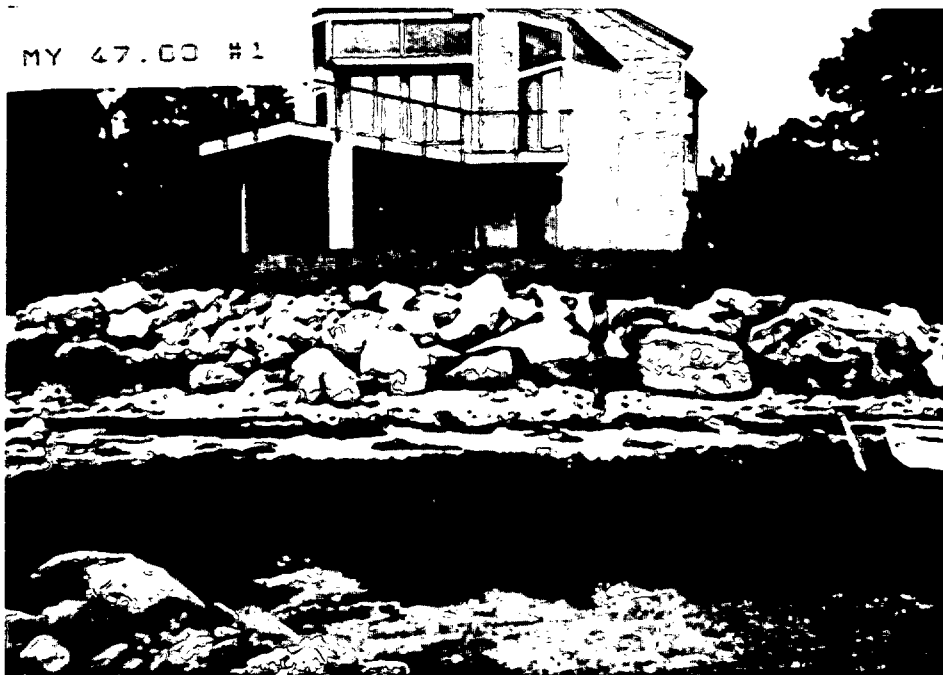
MY 47.00 #1

TYPE OF STRUCTURE: REVETMENT CONDITION: GOOD

MATERIAL : LOOSE BOULDERS

SHORE ON SALT MARSH WITH SANDY SHORE, LOOSE BOULDERS

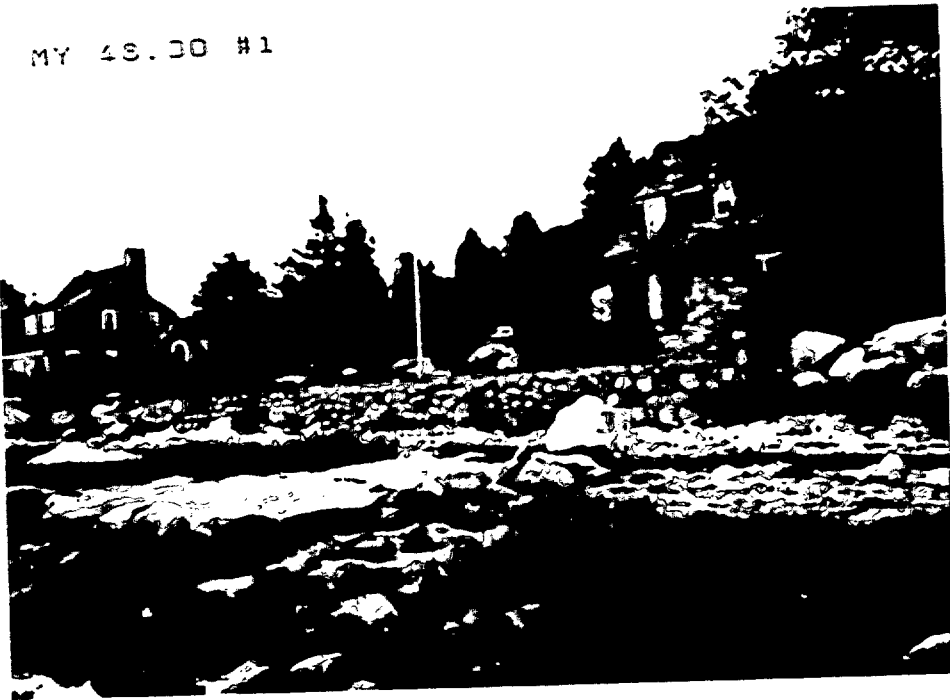
MY 48.30 #1

TYPE OF STRUCTURE: SEAWALL CONDITION: GOOD
MAIN FUNCTION : RETAINS PRIVATE LOT; REVENTS EROSION OF YARD BEHIN
MATERIAL : STONE IN CONCRE

AREA - SALT MARSH WITH SANDY SHORELINE

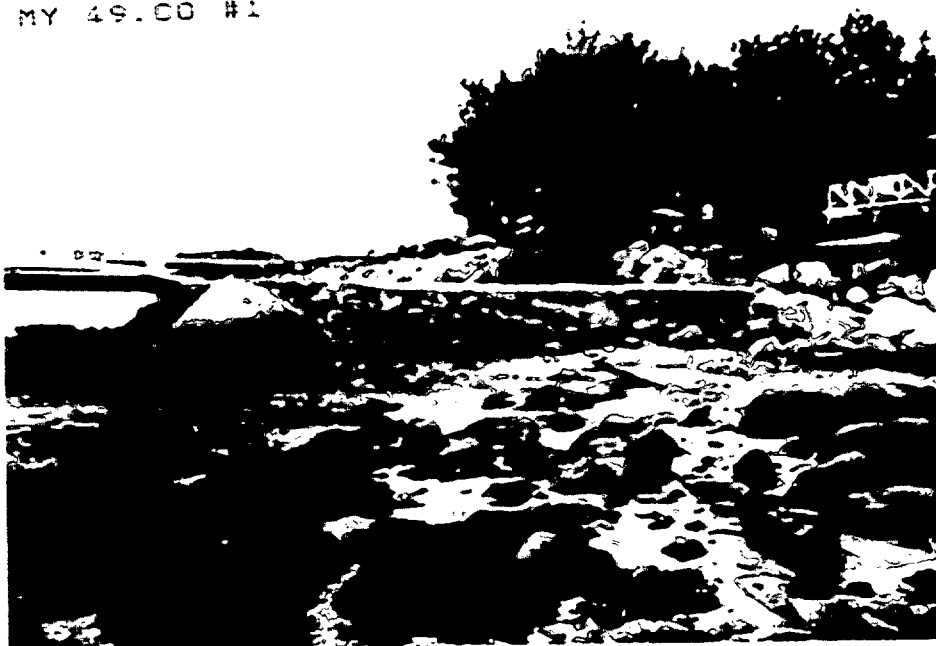
MY 49.00 #1

SAND IN BY FLOATING CLOCKWISE
- SMALL BOULDERS AND RUBBLE SHORE
- LARGE BOULDERS DEPOSITED AT TOE OF SLOPE OF HOUSE LOTS

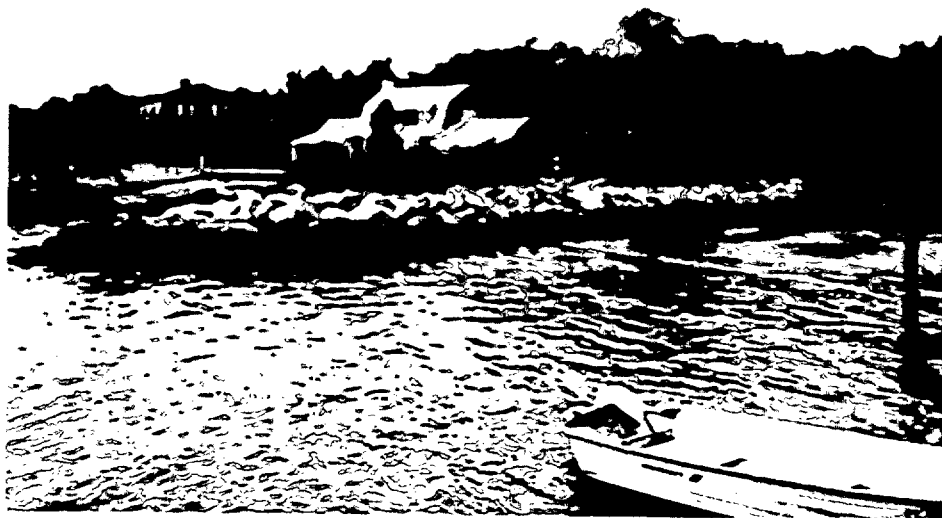
MY 51.00 #1

TYPE OF STRUCTURE: GROIN CONDITION: FAIR
MAIN FUNCTION : PROTECTS SHORE AREA; TRAPS SAND
MATERIAL : STONE

REACH - SALT MARSH AND BOULDERS AND COUBBLES
SOME SAND ACCRETION (?PLACEMENT) BETWEEN AREAS PROTECTED BY
GROINS AND DOCKS

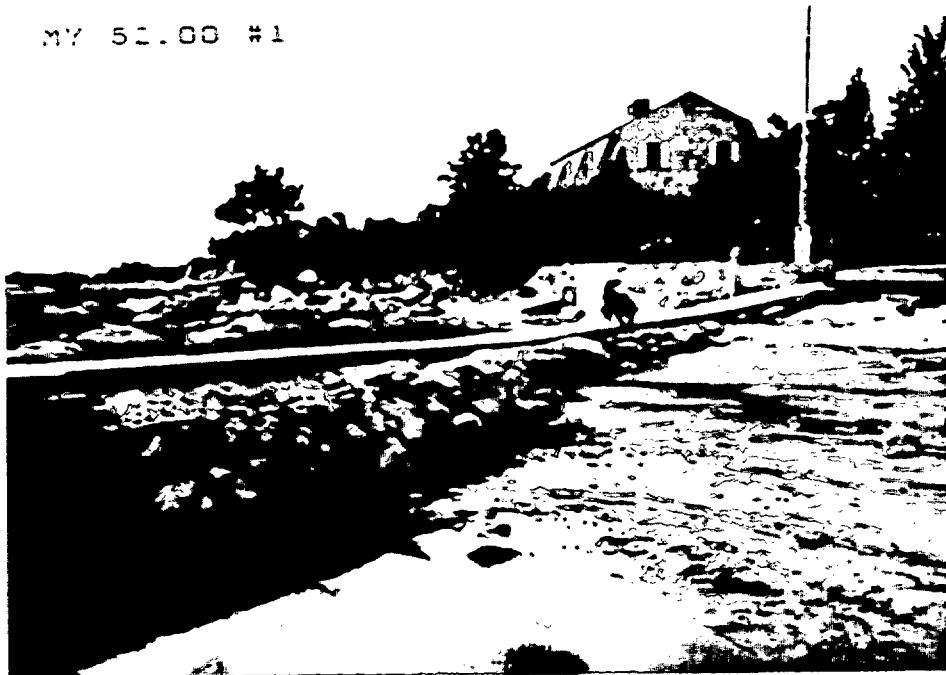
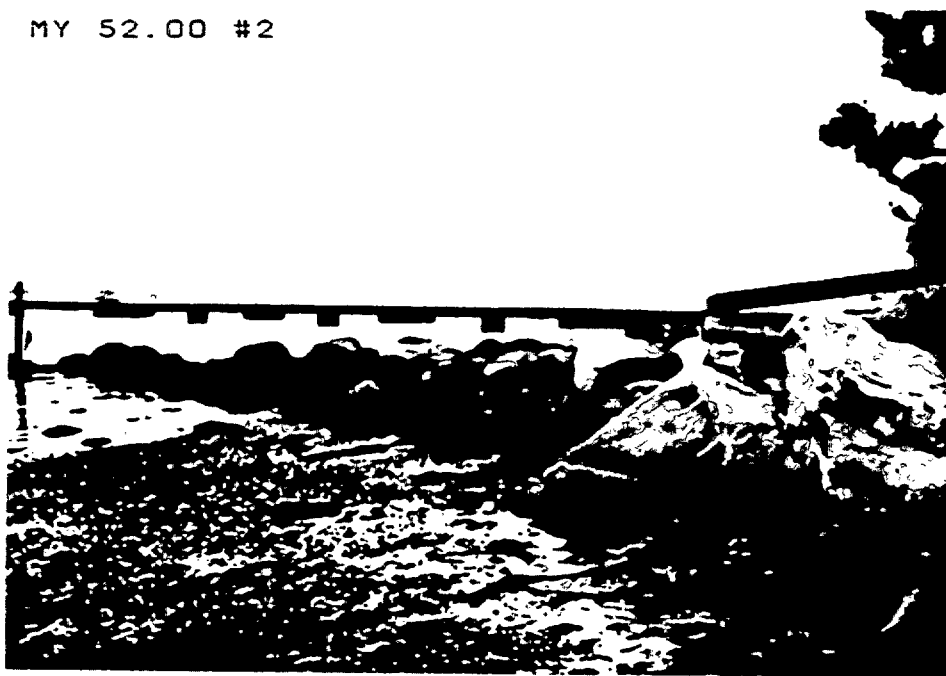
MY 52.00 #1

TYPE OF STRUCTURE: SEAWALL CONDITION: GOOD

LOST FIRST HOUSE DURING HURRICANE OF 1938
BEACH AREA, SAND, SALT MARSH GRASS, AND ROCKS

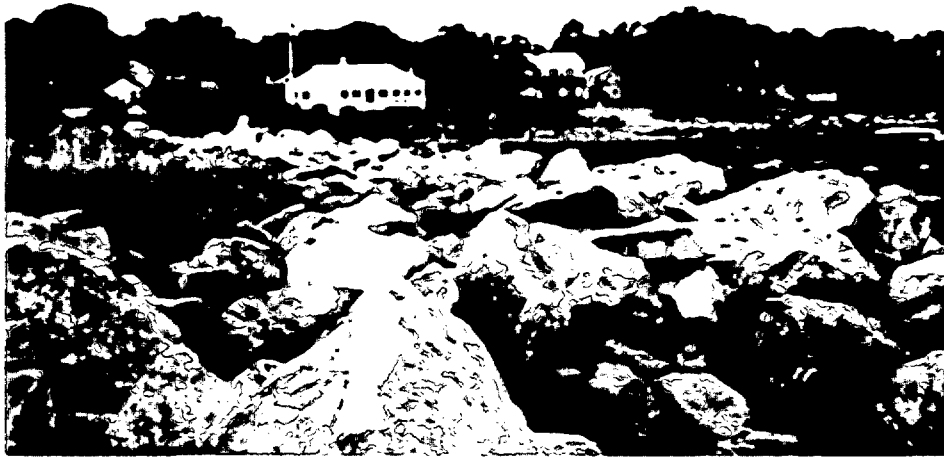
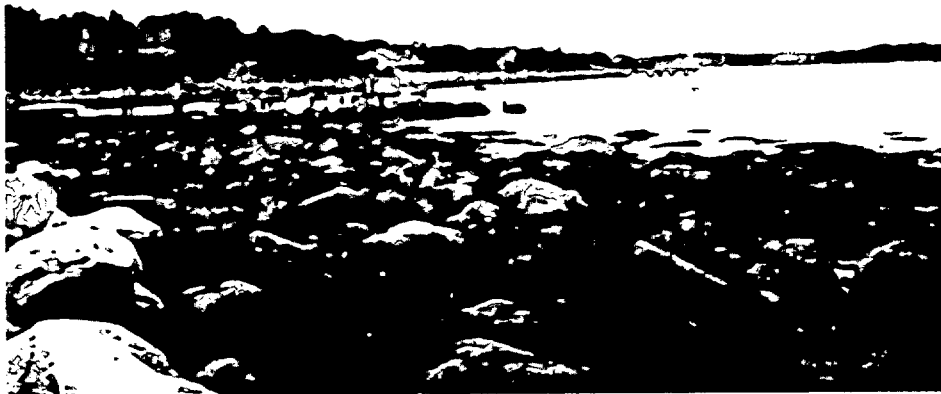
MY 53.00 #1

TYPE OF STRUCTURE: RIP RAP SHRLINE CONDITION: GOOD
MAIN FUNCTION : UNCLEAR-NO EROSION PROTECTION DUE TO NATURAL PROTE
MATERIAL :

AREA - ROCKY SHORELINE; NO SAND, JUST BOULDERS

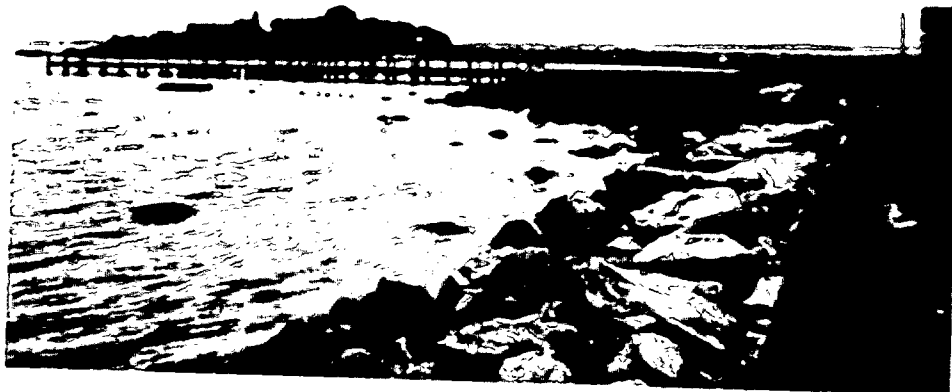
MY 55.CO #1

CONDITION: GOOD

MATERIAL : LOOSE BOULDERS

SMALL BEACH AREA AT FRONT OF MASONS'S ISLAND YACHT CLUB,
REST OF SHORE VERY ROCKY - LARGE BOULDERS

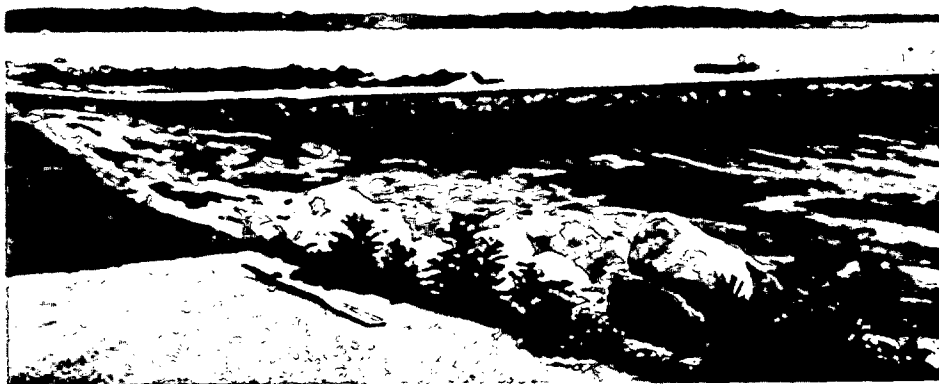
MY 56.00 #1

TYPE OF STRUCTURE: GROIN CONDITION: GOOD
MAIN FUNCTION : ACCESS TO WOODEN PIER/RETAINS SM. PRIV. BEACH IN F
MATERIAL : STONE IN CEMENT

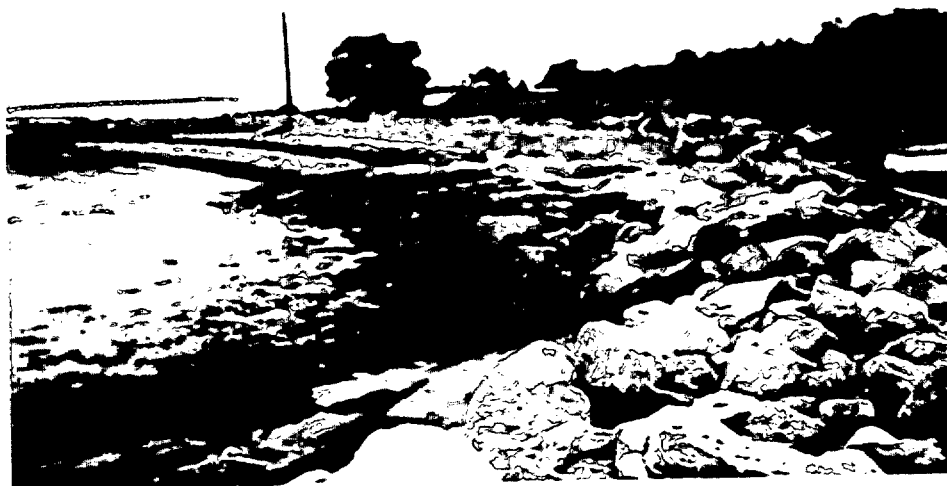
MY 57.00 #1

CONDITION: GOOD

SEAWALL ADJACENT TO BRIDGE TO ENDERS ISLAND

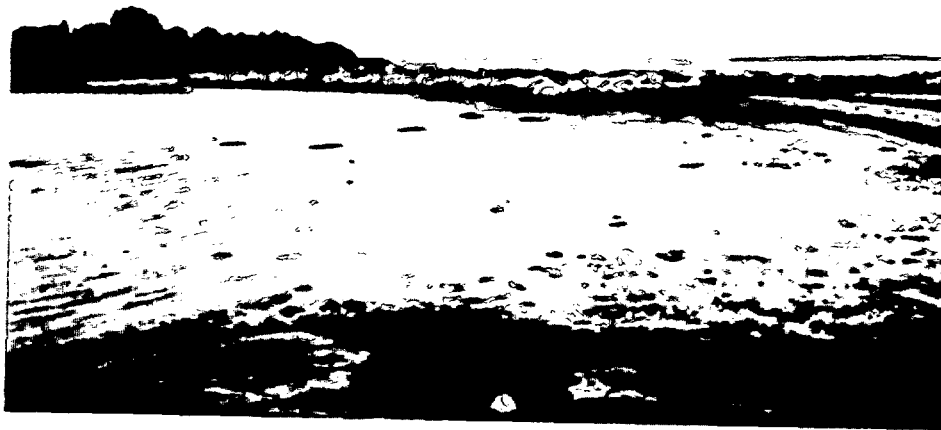
MY 53.00 #1

CONDITION: GOOD

#1 ROLL 6 NEG 14 E. SIDE OF CAUSEWAY FROM MASON ISLE LOOKING S.
#2
#3
#4
#5

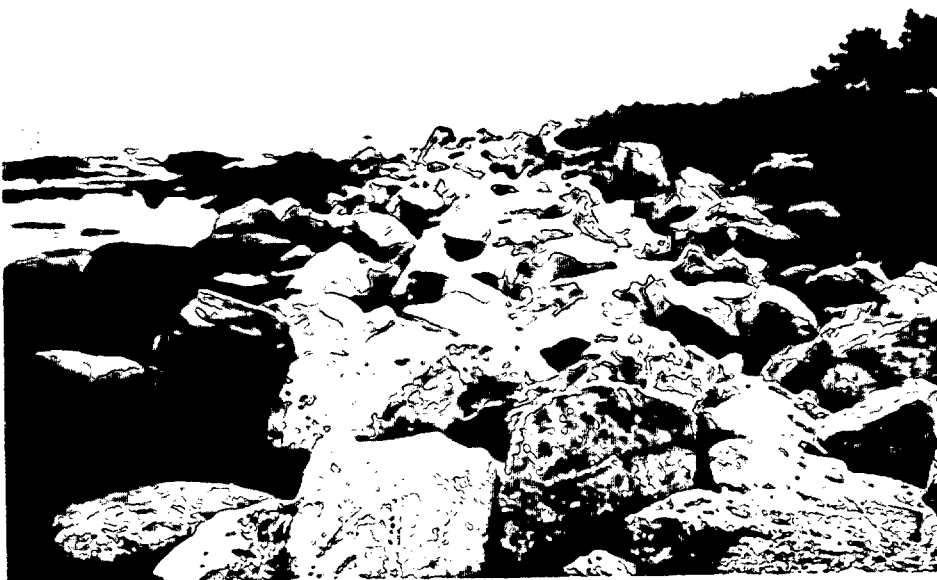
MY 60.00 #1

TYPE OF STRUCTURE: STONE REVETMENT CONDITION: GOOD
MAIN FUNCTION : PREVENTS EROSION
MATERIAL : STONE

AREA - ENDERS ISLAND COMPLETELY LINED WITH WALLS & BOULDER
REVETMENTS

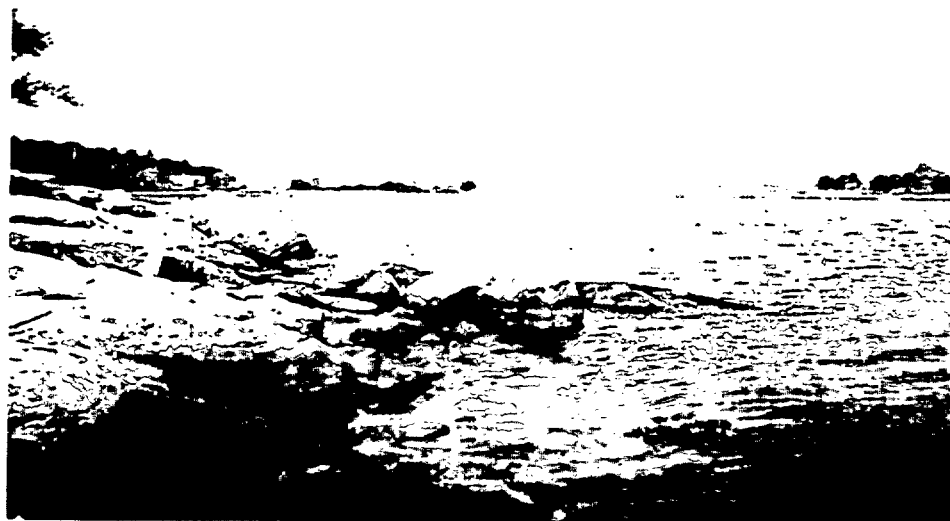
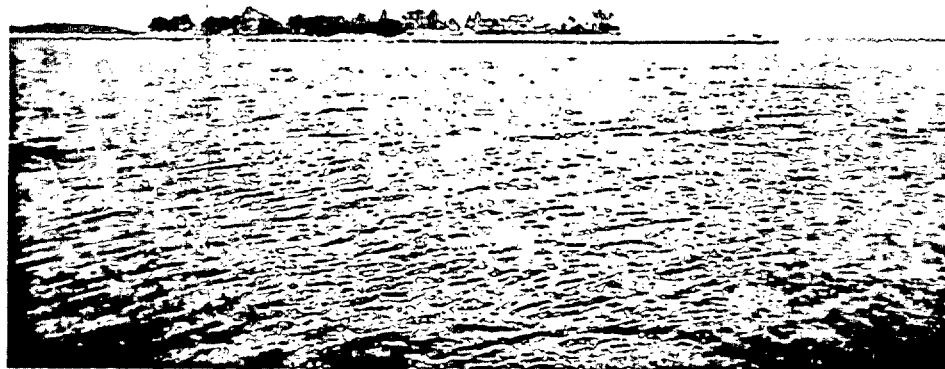
NY 61.00 #1

CONDITION: GOOD

AREA - SEE #60

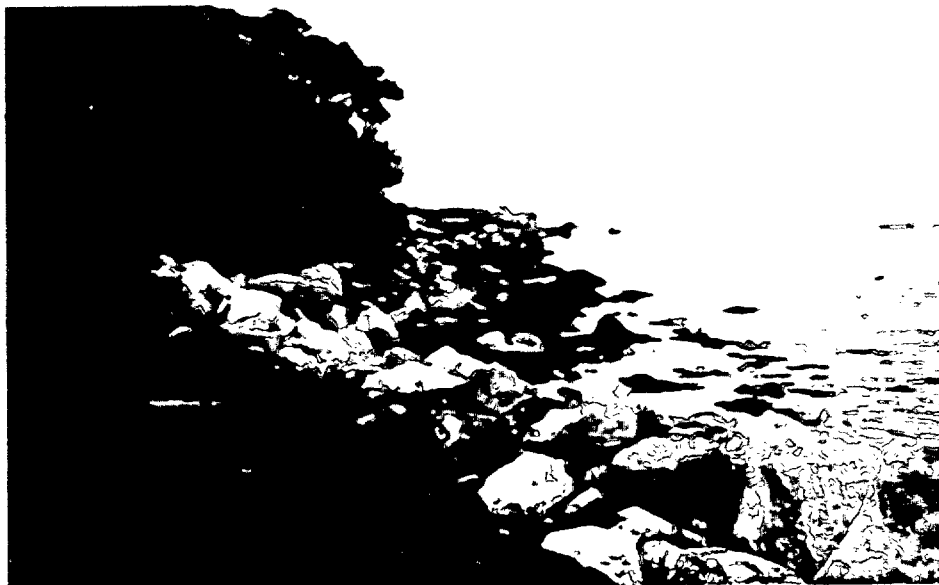
MY 62.00 #1

TYPE OF STRUCTURE: RIPRAP CONDITION: GOOD
MAIN FUNCTION : TO PREVENT EROSION OF SHORELINE
MATERIAL : STONE

ENTIRE SHORELINE OF ISLAND LINED WITH WALLS AND REVETMENTS

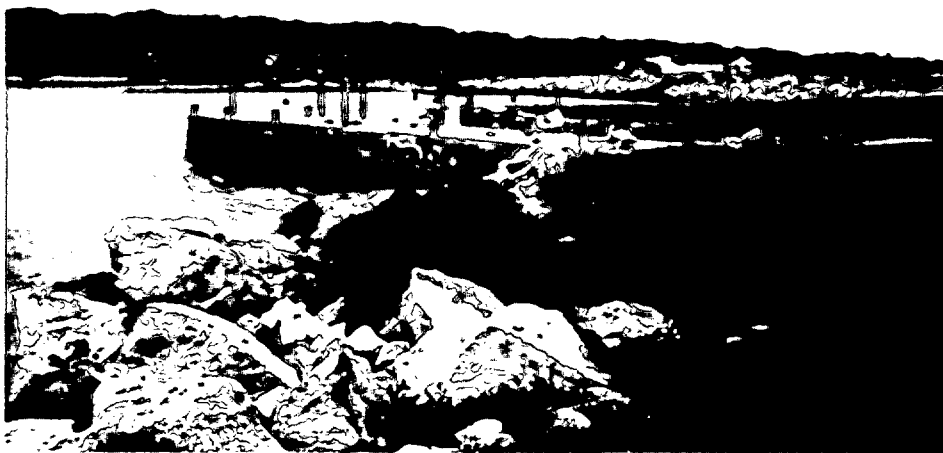
MY 63.00 #1

TYPE OF STRUCTURE: PIER CONDITION: GOOD
MAIN FUNCTION : RECREATIONAL, TRAPS SAND ON SOUTH SIDE
MATERIAL : STONE IN CEMENT

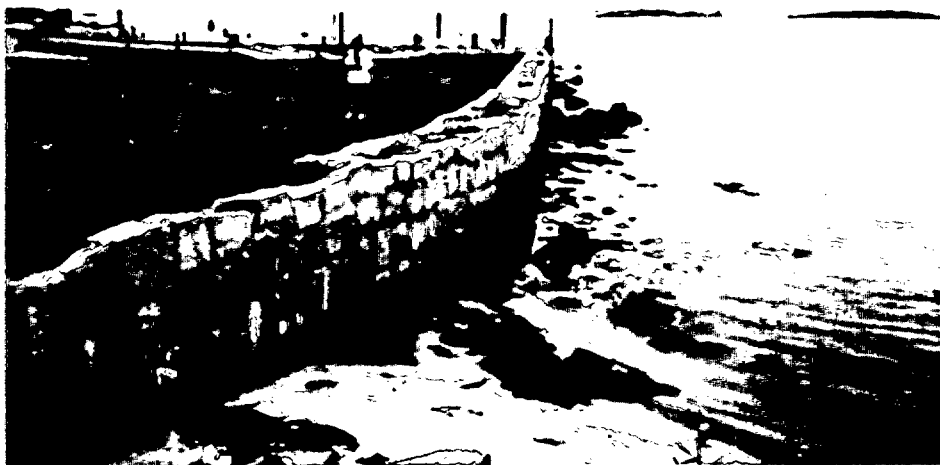
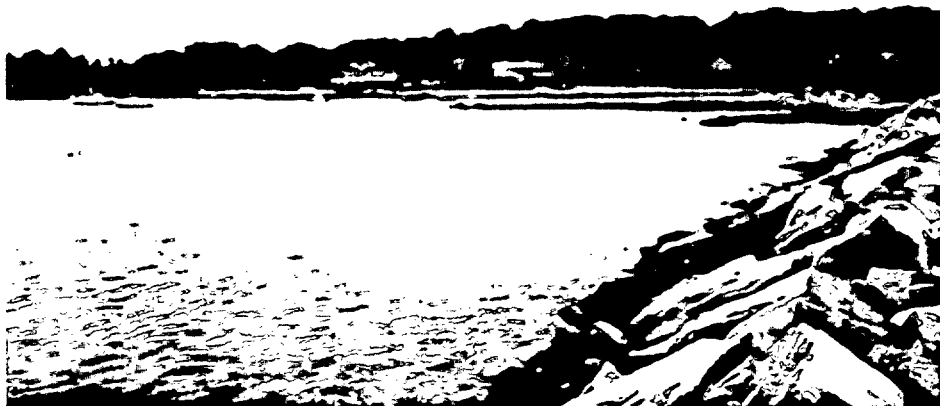
MY 64.00 #1

TYPE OF STRUCTURE: SEAWALL CONDITION: GOOD
MAIN FUNCTION : TO PREVENT EROSION
MATERIAL : STONE&CONCRETE

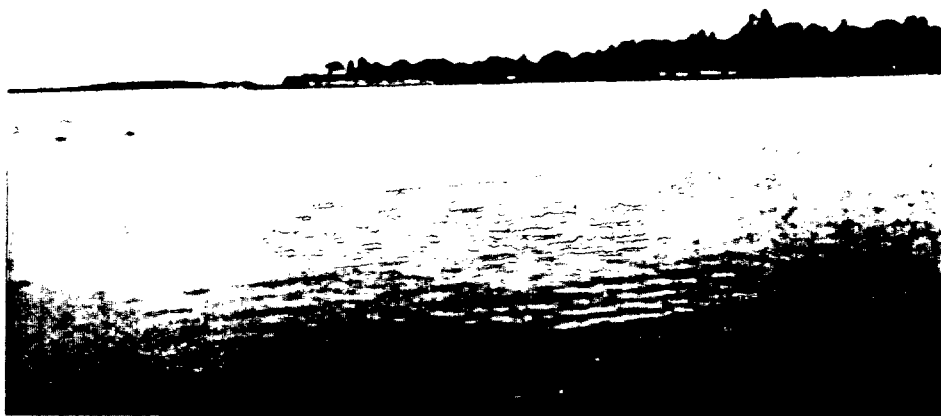
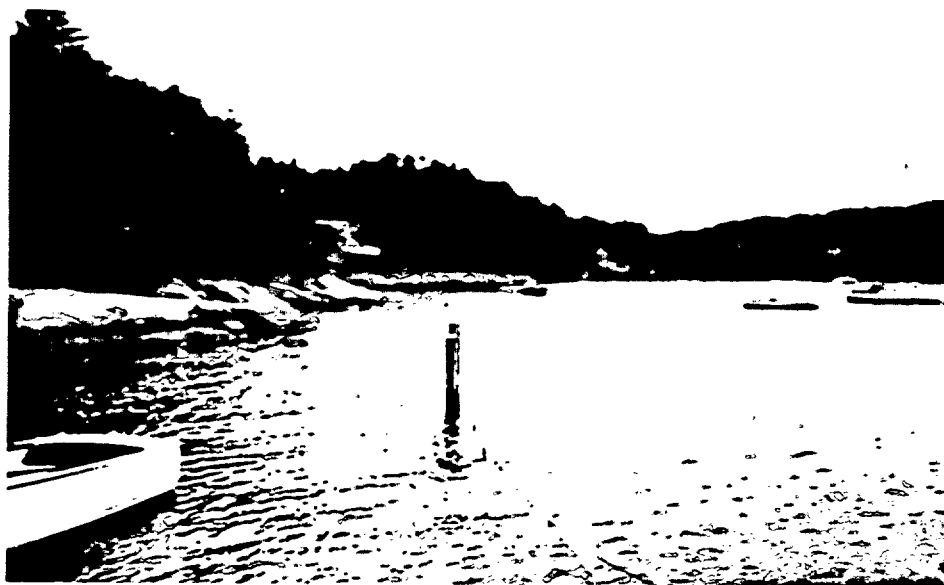
MY 65.00 #2

TYPE OF STRUCTURE: BULKHEAD CONDITION: GOOD
MAIN FUNCTION : PROTECTION OF SLOPE FROM EROSION
MATERIAL : STONE&CONCRETE

ROCKY SHORE

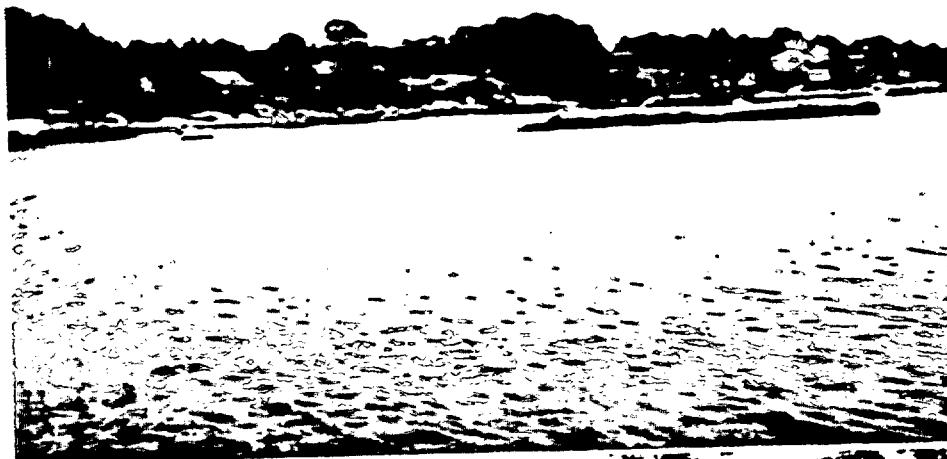
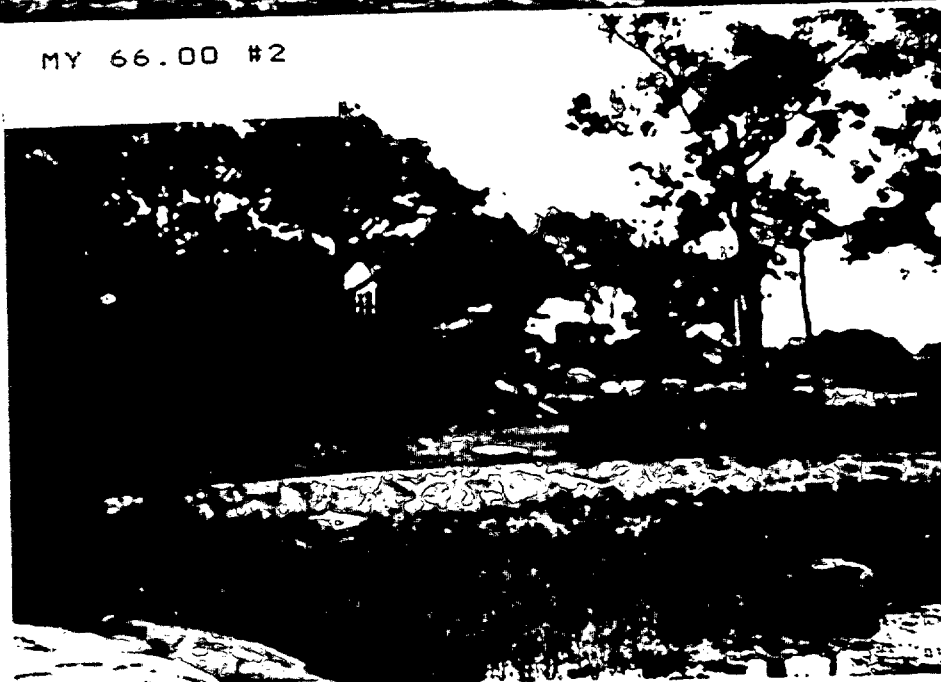
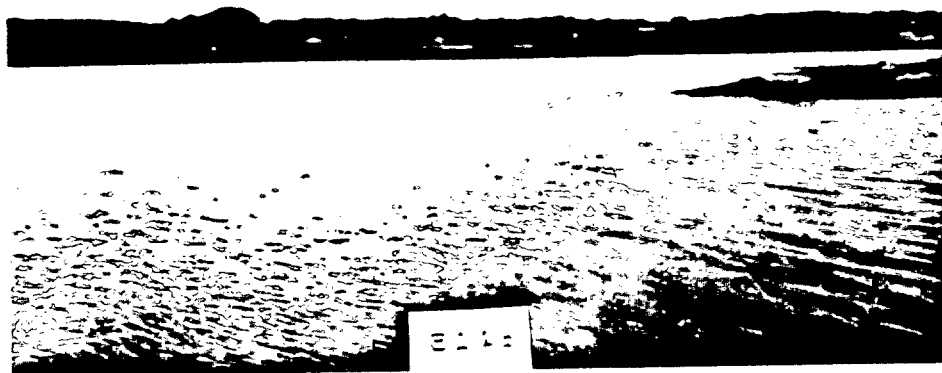
MY 66.00 #2

TYPE OF STRUCTURE: BULKHEAD CONDITION: GOOD
MAIN FUNCTION : RETAINS YARD IN FRONT OF HOME
MATERIAL : STONE&CONCRETE

NO EROSION PROTECTION NECESSARY

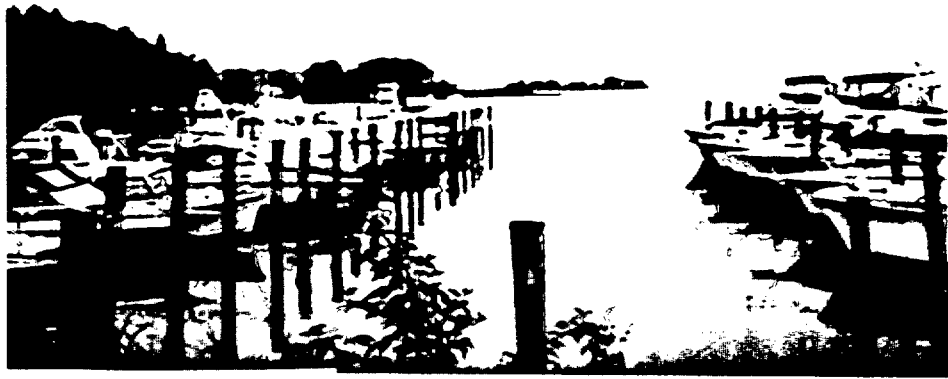
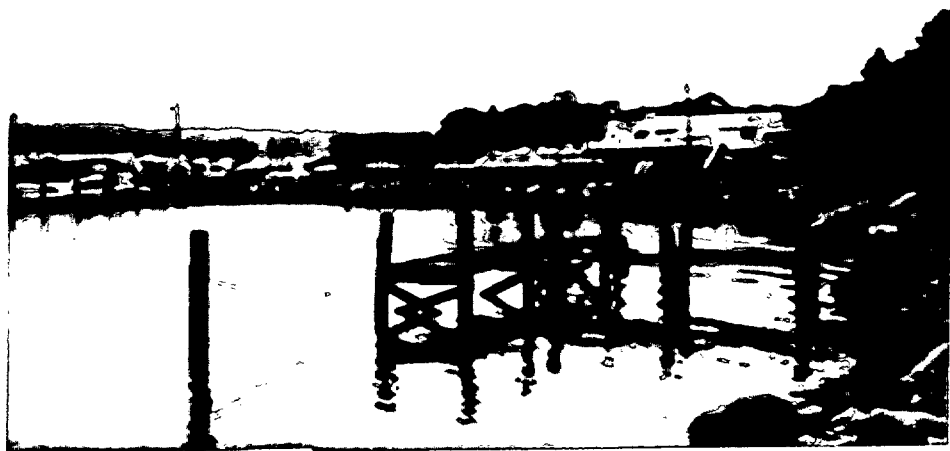
MY 67.00 #1

TYPE OF STRUCTURE: REVETMENT CONDITION: GOOD
MAIN FUNCTION : PROTECTION OF SLOPE
MATERIAL : STONE

AREA OF MARINA - SEVERAL DOCKS FOR MOORING

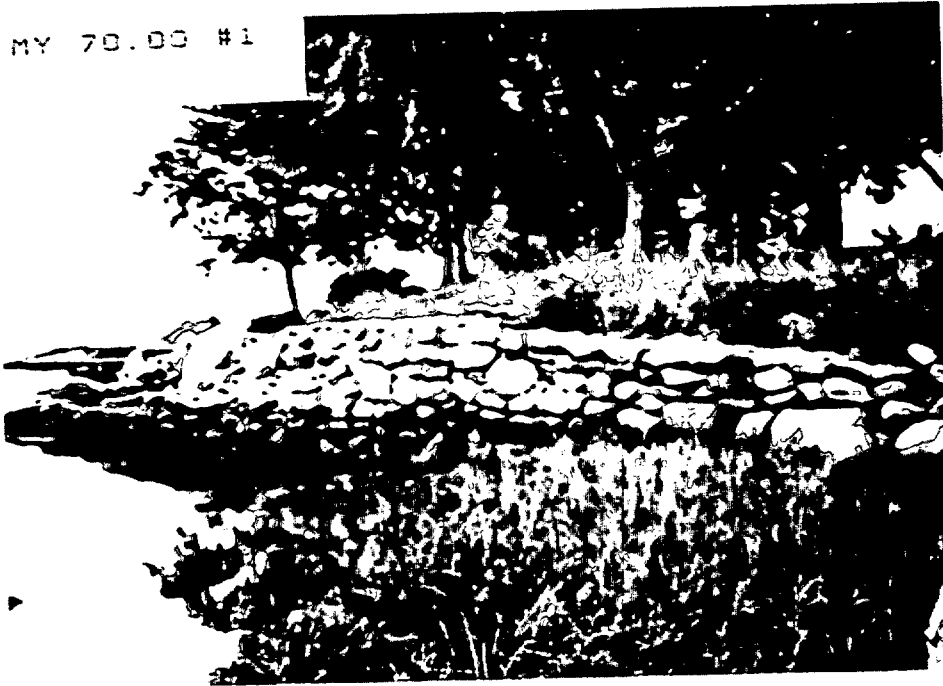
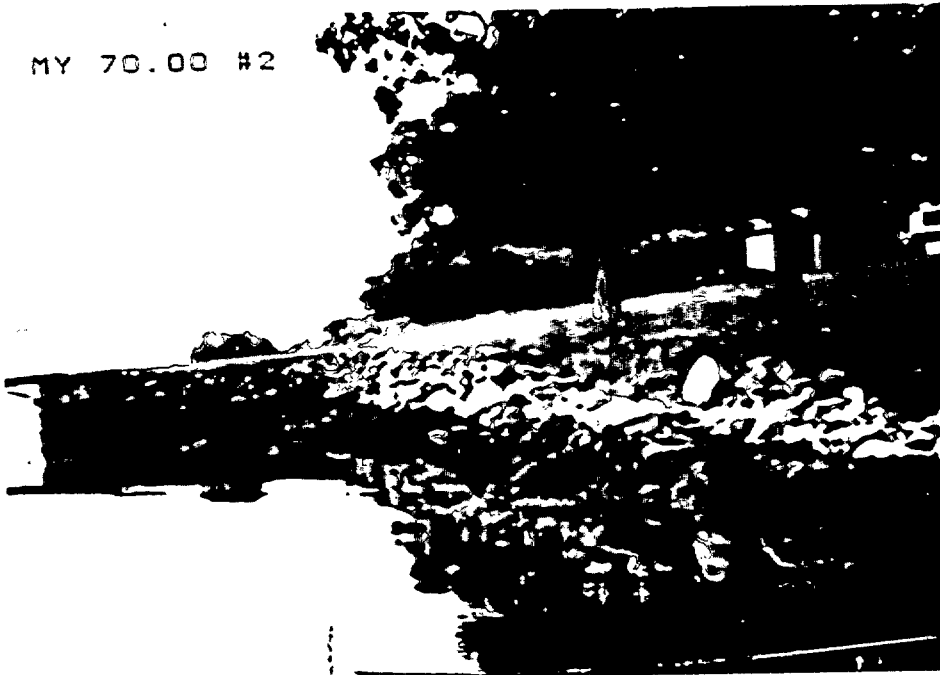
MY 70.00 #1

TYPE OF STRUCTURE: BULKHEAD CONDITION: FAIR
MAIN FUNCTION : PROTECTION AND SUPPORT OF LAND
MATERIAL : STONE&CEMENT

SHORELINE ROCKY WITH PATCHES OF MARSH

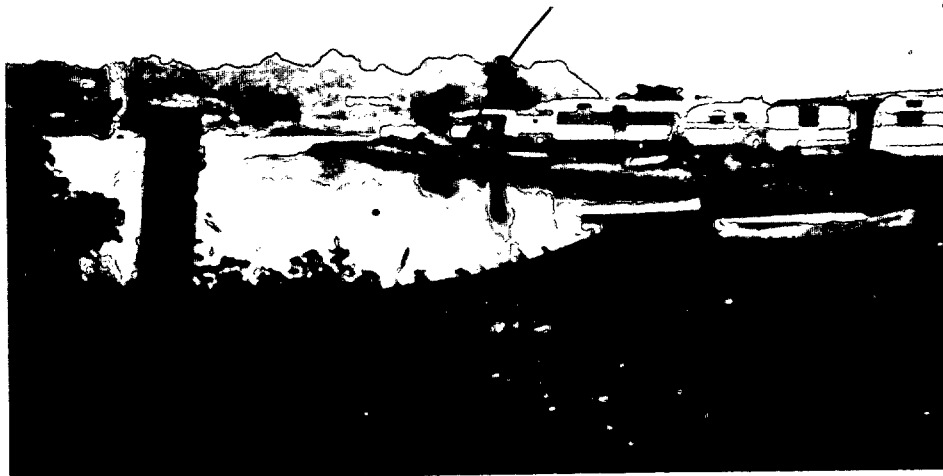
MY 71.00 #1

TYPE OF STRUCTURE: SEAWALL CONDITION: POOR
MAIN FUNCTION : PROTECTION OF MOBILE HOME PARK
MATERIAL : CINDER BLOCKS

BROWERS COVE MARINA - NO EROSION CONTROL - DOCKS FOR
RECREATION. ADJACENT TO MARINA IS TRAILER PARK ON SMALL
PENNINSULA.

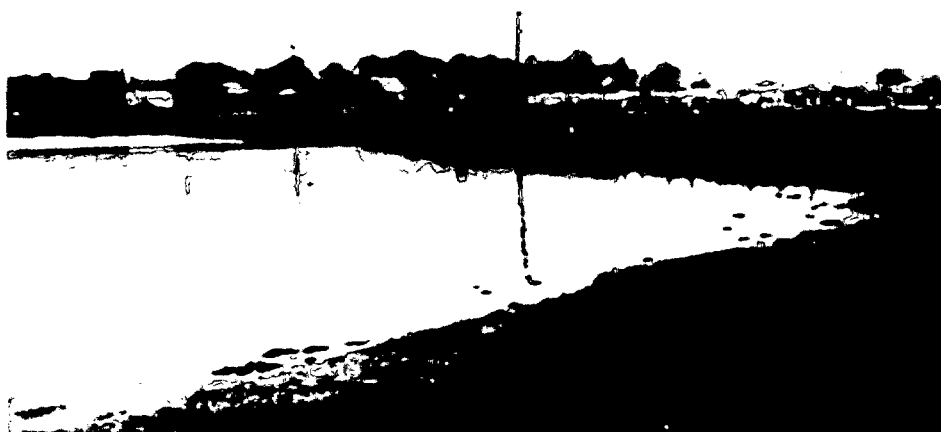
MY 72.00 #1

TYPE OF STRUCTURE: CAUSEWAY TO IS. CONDITION: FAIR
MAIN FUNCTION : PROTECTION OF ROAD
MATERIAL : STONE

#1 ROLL 7 NEG 9 CAUSEWAY
#2
#3
#4
#5

CAUSEWAY CONNECTS ISLAND TO MAINLAND.

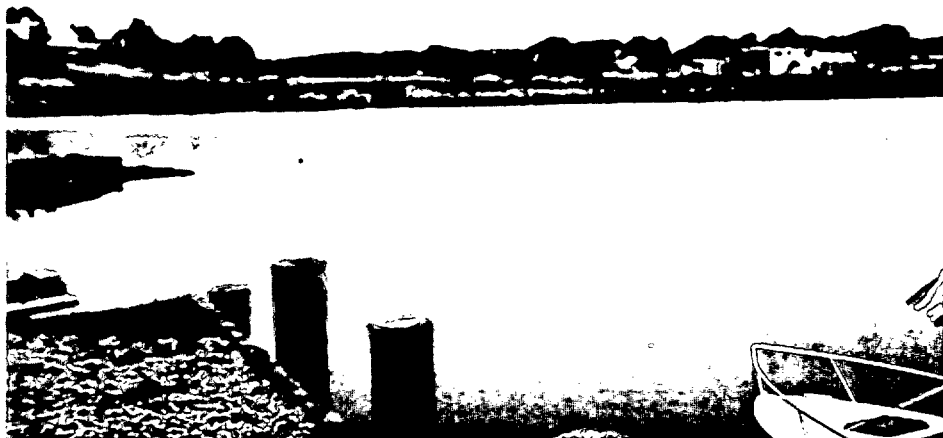
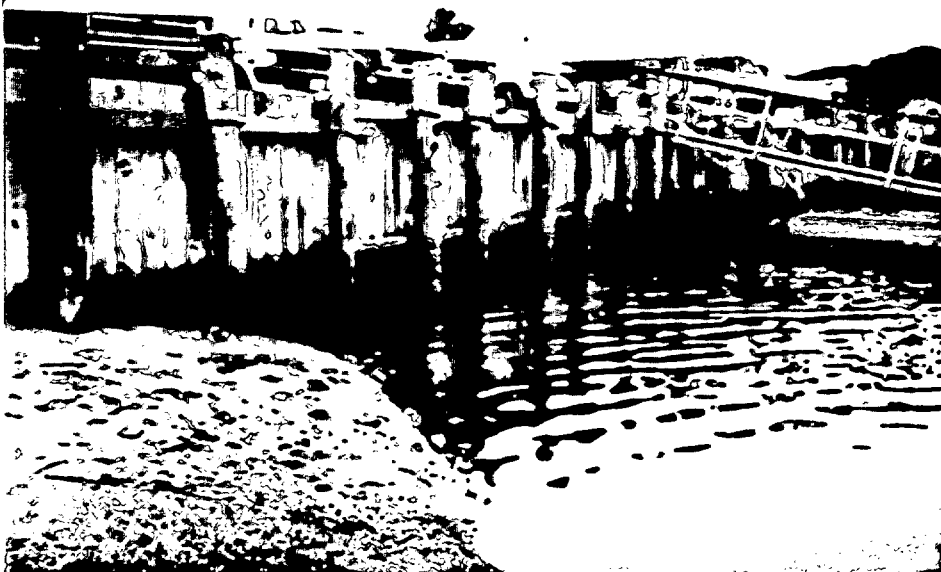
MY 73.00 #1

TYPE OF STRUCTURE: BULKHEAD CONDITION: GOOD
MAIN FUNCTION : RETAINS LAND UNDER PARKING LOT. PREVENTS WAVE ERO
MATERIAL : WOOD

MARINA AND BOAT SALES

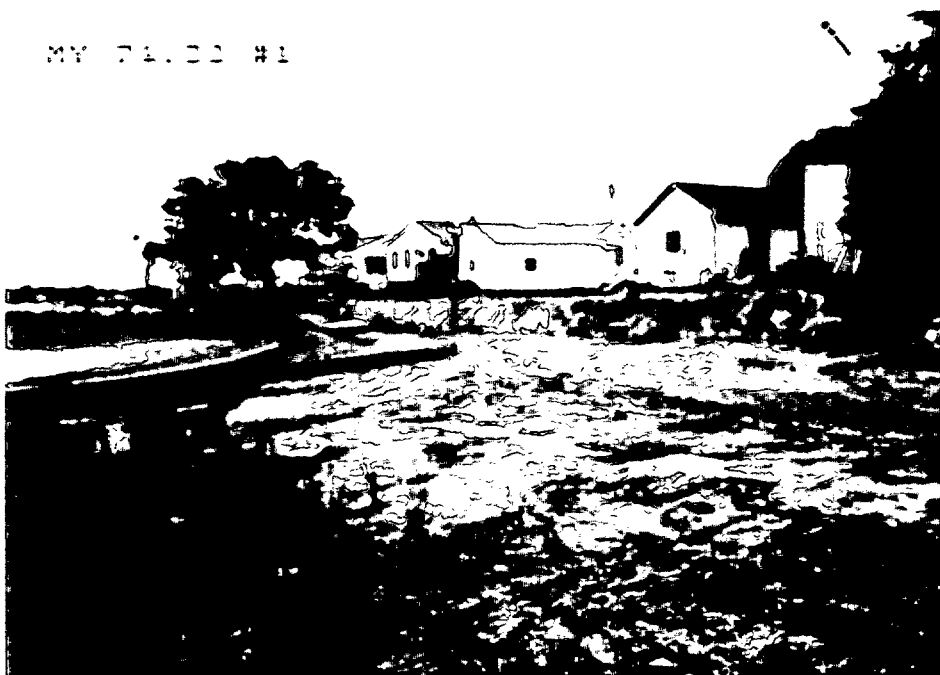
MY 71.22 #1

TYPE OF STRUCTURE: SEAWALL CONDITION: FAIR
MAIN FUNCTION : PREVENT EROSION FROM YARDS
MATERIAL : CONCRETE

SHORE IS MUD FLATS WITH SALT MARSH

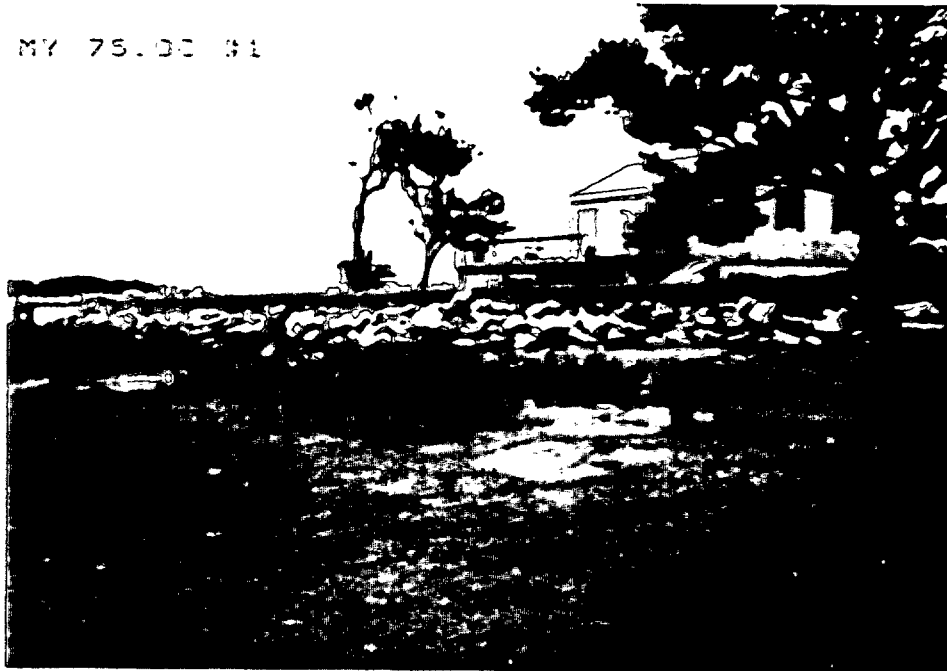
MY 75.00 51

TYPE OF STRUCTURE: SEAWALL CONDITION: FAIR
MAIN FUNCTION : PROTECTION AND RETENTION
MATERIAL : CEMENT & STONE

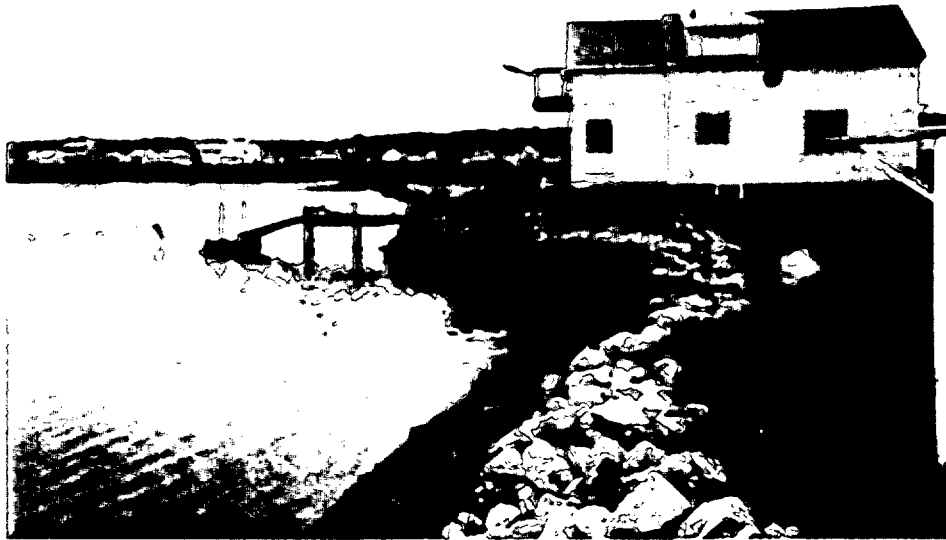
NY 76.00 #1

TYPE OF STRUCTURE: SEAWALL CONDITION: POOR
MAIN FUNCTION : RETAINS PROPERTY, PREVENT EROSION
MATERIAL : STONE

HOMEOWNERS WORKING ON SEAWALL TO REPAIR IT
